## **Testing for Ammonia Odor from Urinals**

This paper reports the results of testing for ammonia odor at non-water urinals installed in selected Oregon State Park restrooms. 'Non-water urinals' refers to urinals that are similar to common porcelain water-flushed urinals, except that they do not require flush water.

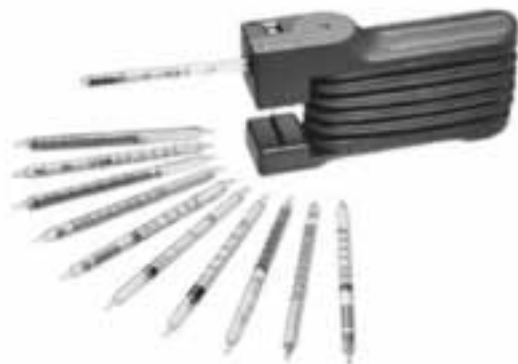
Sampler pumps and tubes, a common ammonia detection tool, were used for ammonia detection. Figure 1 shows a Dräger pump with tubes. The sampler pump and tube method of ammonia detection requires entering the restroom facility and manually drawing the samples according to the pump manufacturer's instructions. The reactant in the sampler tube usually consists of carbon/silica gel beads impregnated with sulfuric acid. The color of the reactant beads within the tube changes in the presence of ammonia and is read from a scale. Figure 2 shows a sampler tube with an indicated ammonia concentration of 5ppm. The sampler tubes are read directly when used with the Dräger bellows pump, which provides a known volume of sampled air.

**Figure 1: Dräger bellows sampler pump with tubes.**
